NIST NCSTAR 2: Vol. I

Report of the Technical Investigation of The Station Nightclub Fire

June 2005

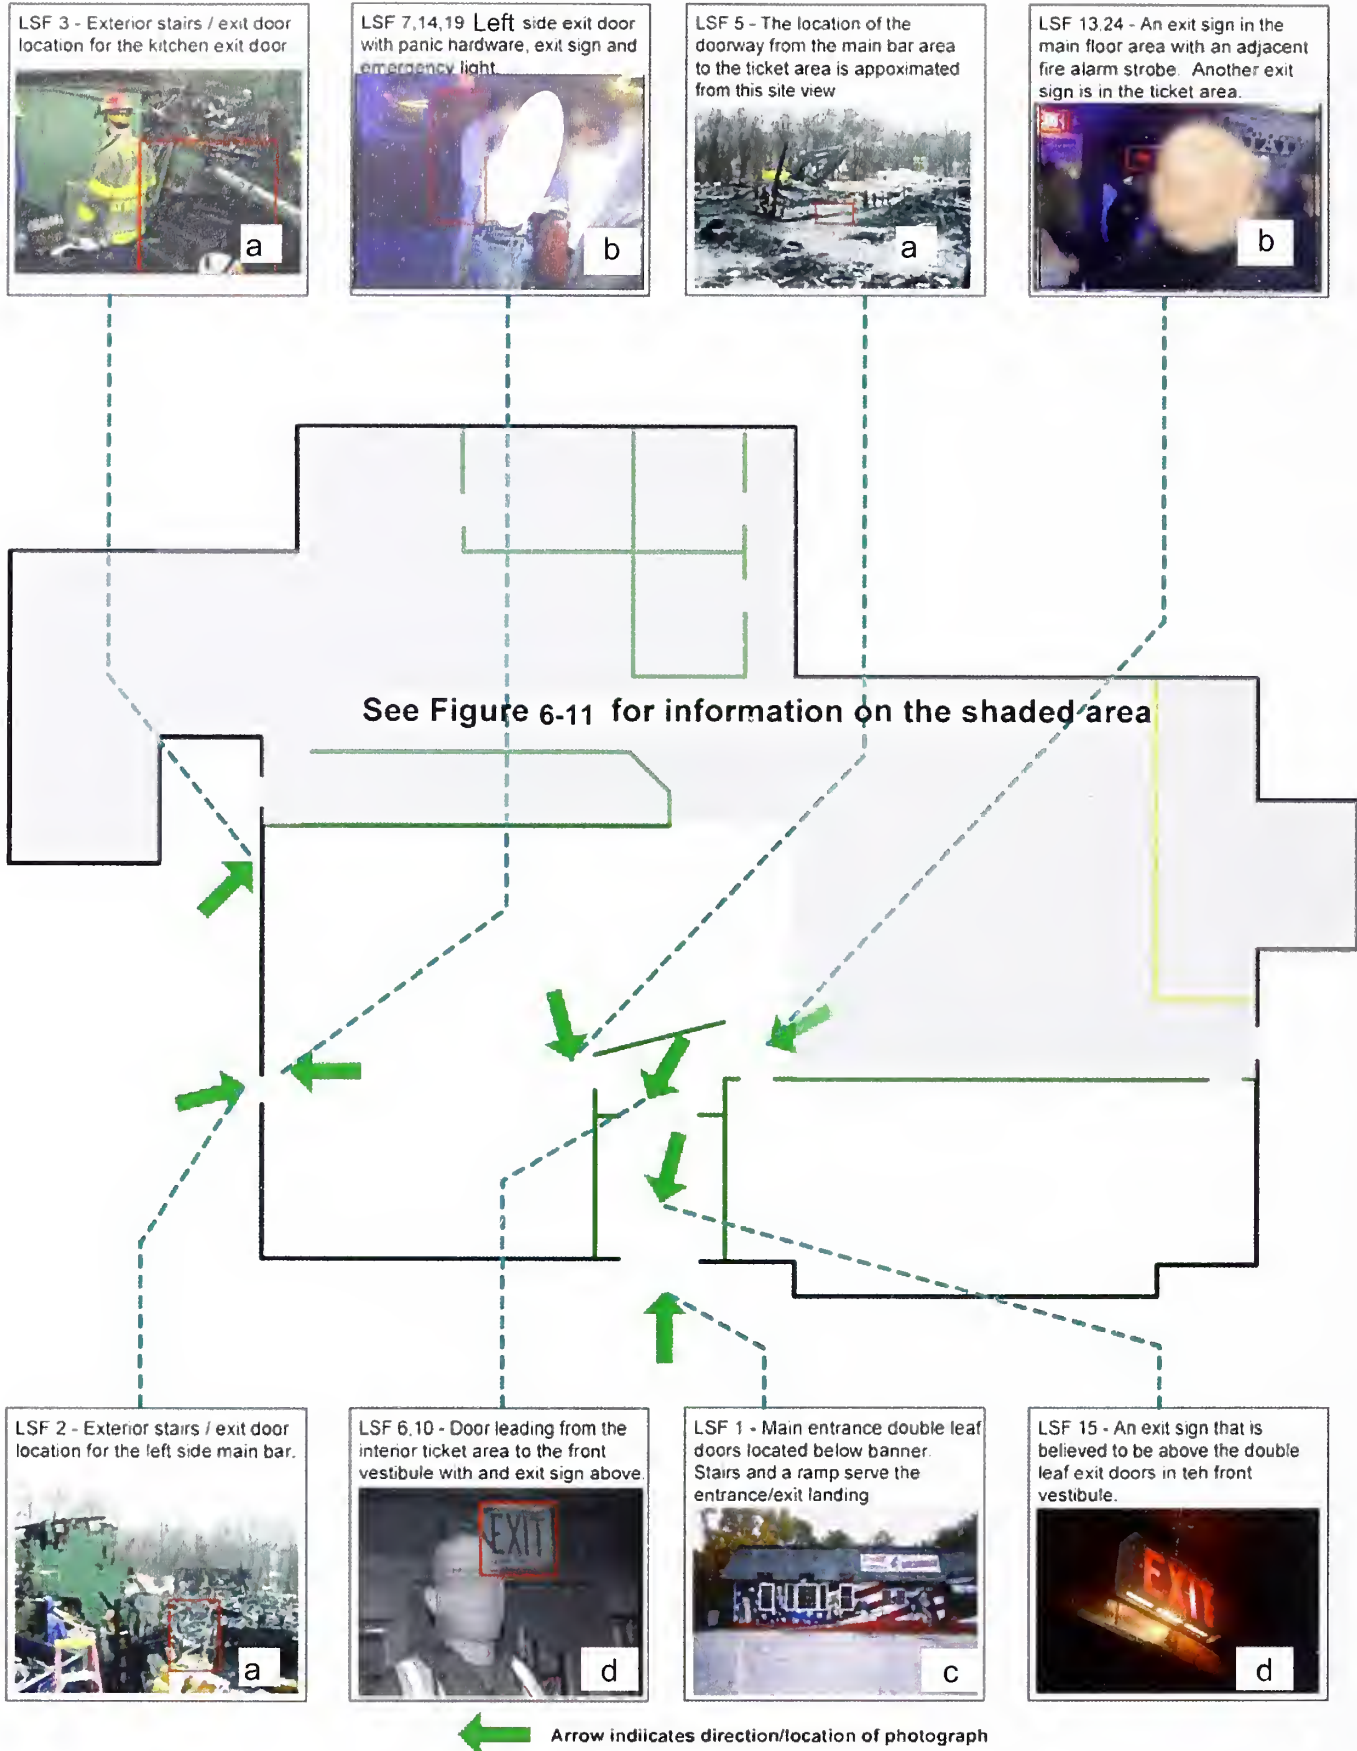
Figure 6-10. Summary of Life Safety Features – Part 1

Egress through the main entrance to the building was limited by a single interior door (LSF 6 in Figure 6-10) not the double doors that could be seen from outside the building.

LSF 9.	Exit sign located near the rear bar; it appears to be pointing toward the kitchen exit door.
LSF 10.	Exit sign above the door that leads from the ticket area to the front vestibule.
LSF 11.	Exit sign above the platform door. Note that in this image the sign is clearly illuminated.
LSF 12.	Exit sign above the platform door on February 20, 2003. Note that in this image the sign does not appear to be illuminated. NOTE: This is a duplicate of LSF 12, but was included to show that the exit sign may not have always been illuminated.
LSF 13.	Two exit signs. One located in the main floor area with an arrow towards the ticket area and another above the ticket area doors leading to the front vestibule.
LSF 14.	Exit sign over the left side main bar area exit door.
LSF 15.	Exit sign located in the front vestibule above the main double exit doors. This location is based upon similar wall and ceiling features observed in the WPRI video.

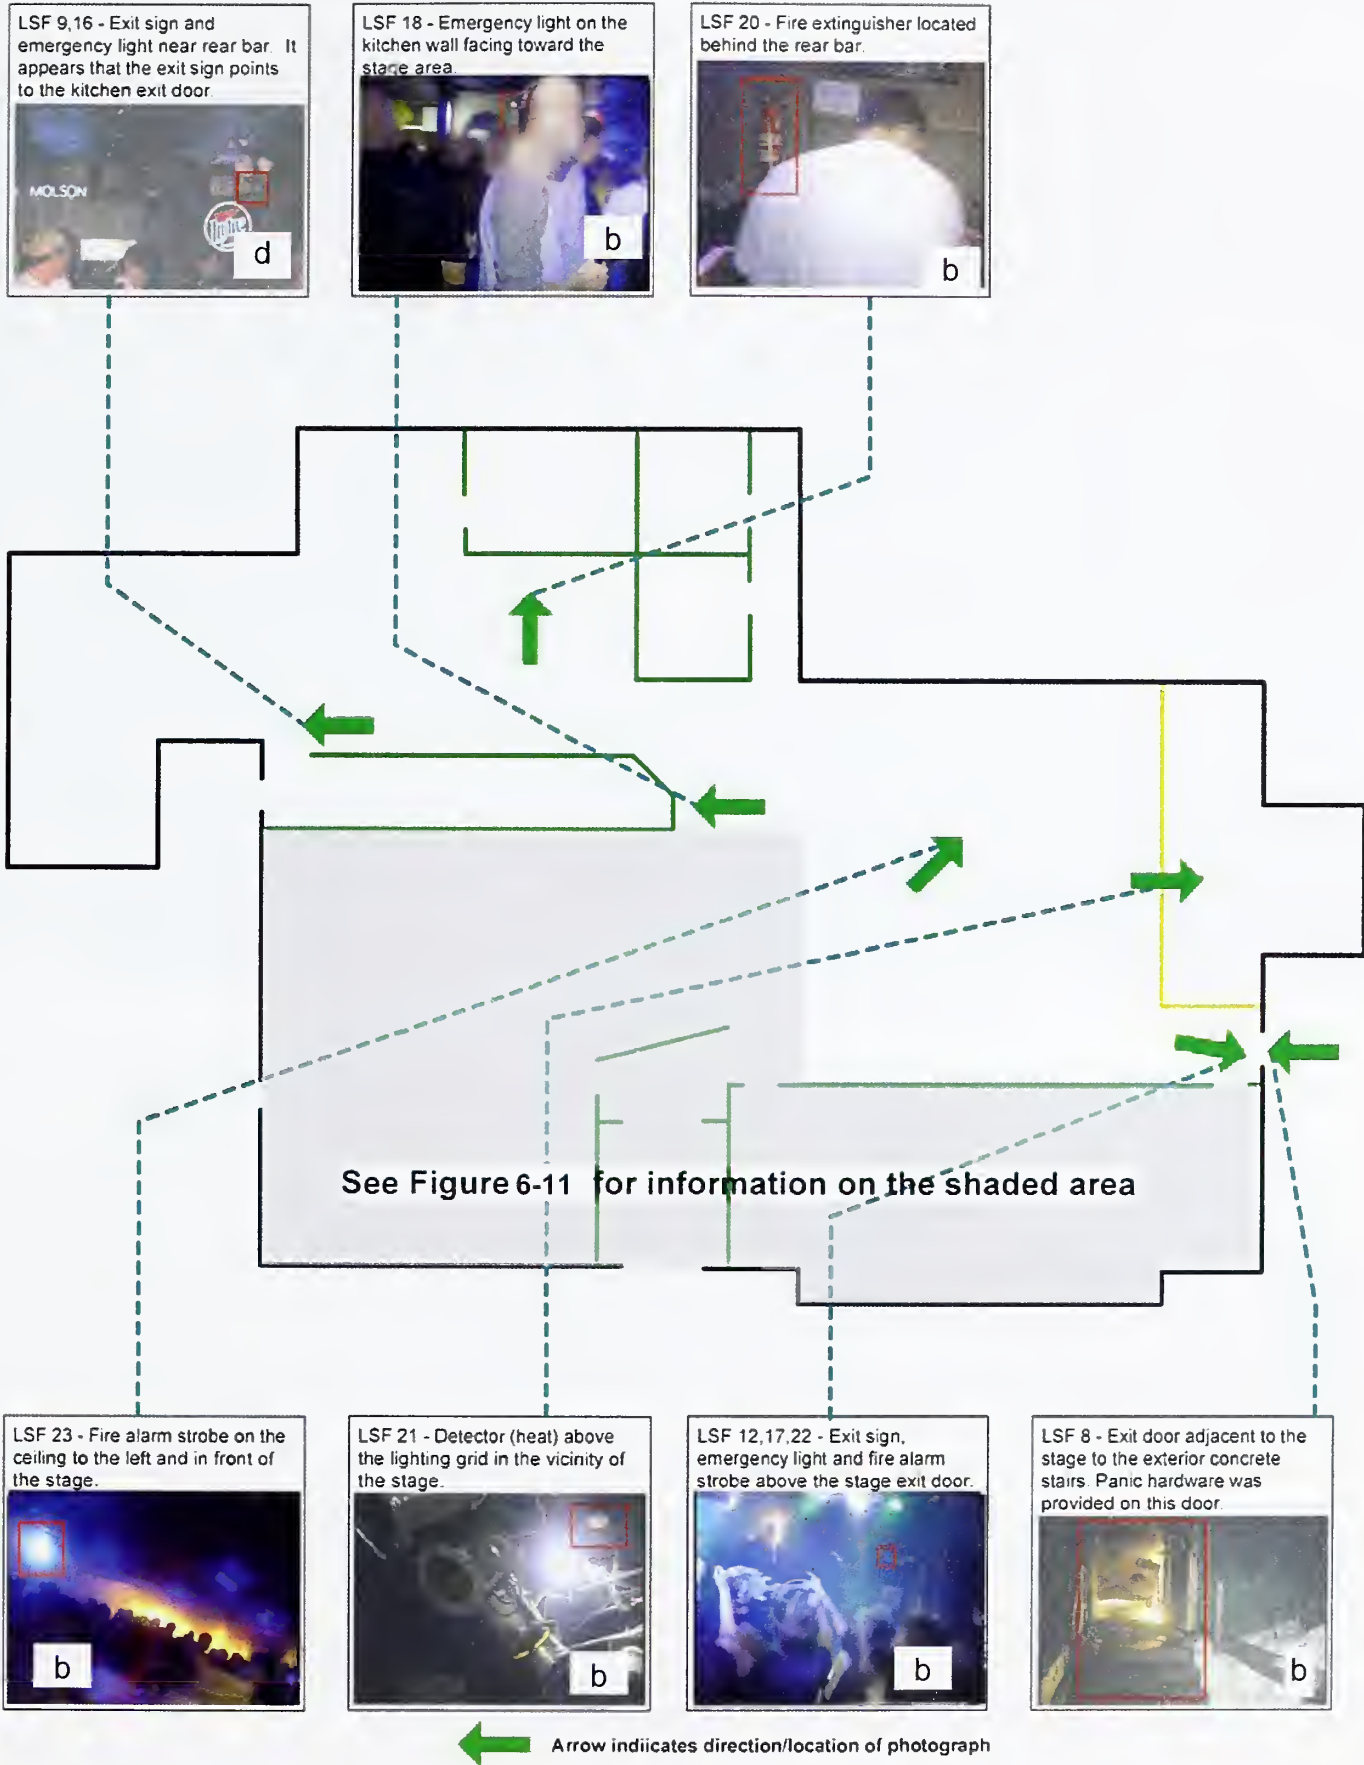
Figure 6-11. Summary of Life Safety Features – Part 2

LSF 16.	Emergency light located near the rear bar.
LSF 17.	Emergency light above and to the right of the platform exit door.
LSF 18.	Emergency light on the wall adjacent to the kitchen by the main bar facing into the main floor area.
LSF 19.	Emergency light above and to the right of the left side exit door from the main bar area.
LSF 20.	Fire extinguisher located behind the rear bar.
LSF 21.	Detector (heat) located above the lighting grid on the ceiling near the platform.
LSF 22.	Fire alarm strobe adjacent to the exit sign above the platform exit door.
LSF 23.	Fire alarm strobe on the ceiling to the left and in front of the platform.
LSF 24.	Fire alarm strobe on the wall adjacent to the exit sign in the main floor area pointing toward the ticket area.

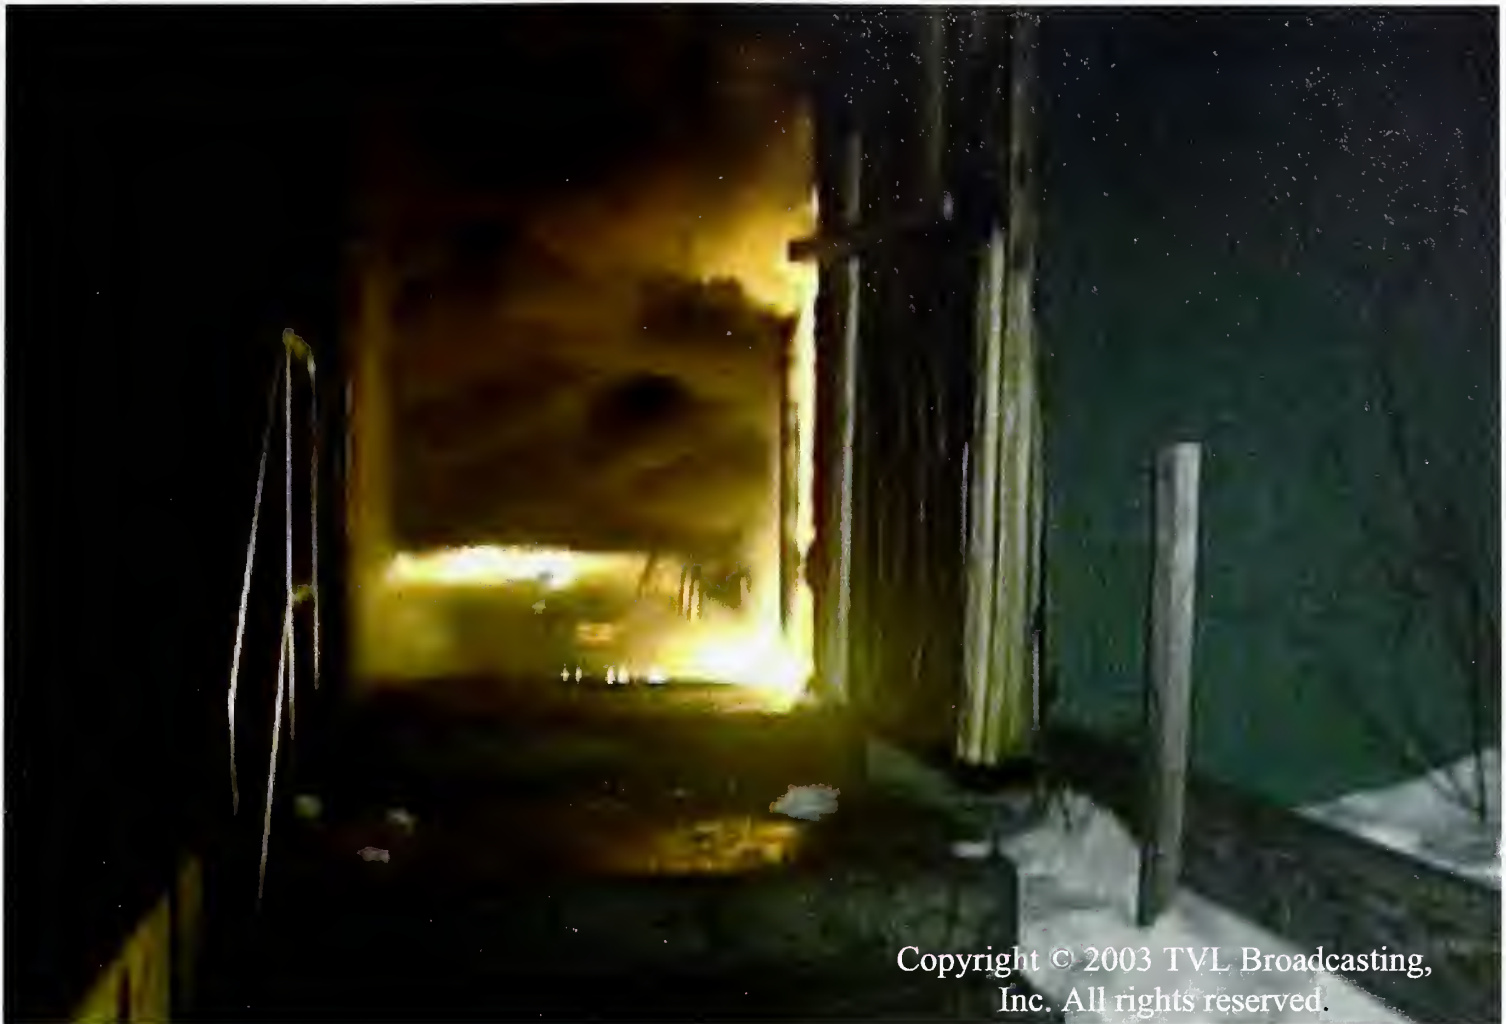
Figure 6-13. Exit Door Near Platform [2]

- Platform exit door swings in the wrong direction;
- Panic hardware on platform door is broken.

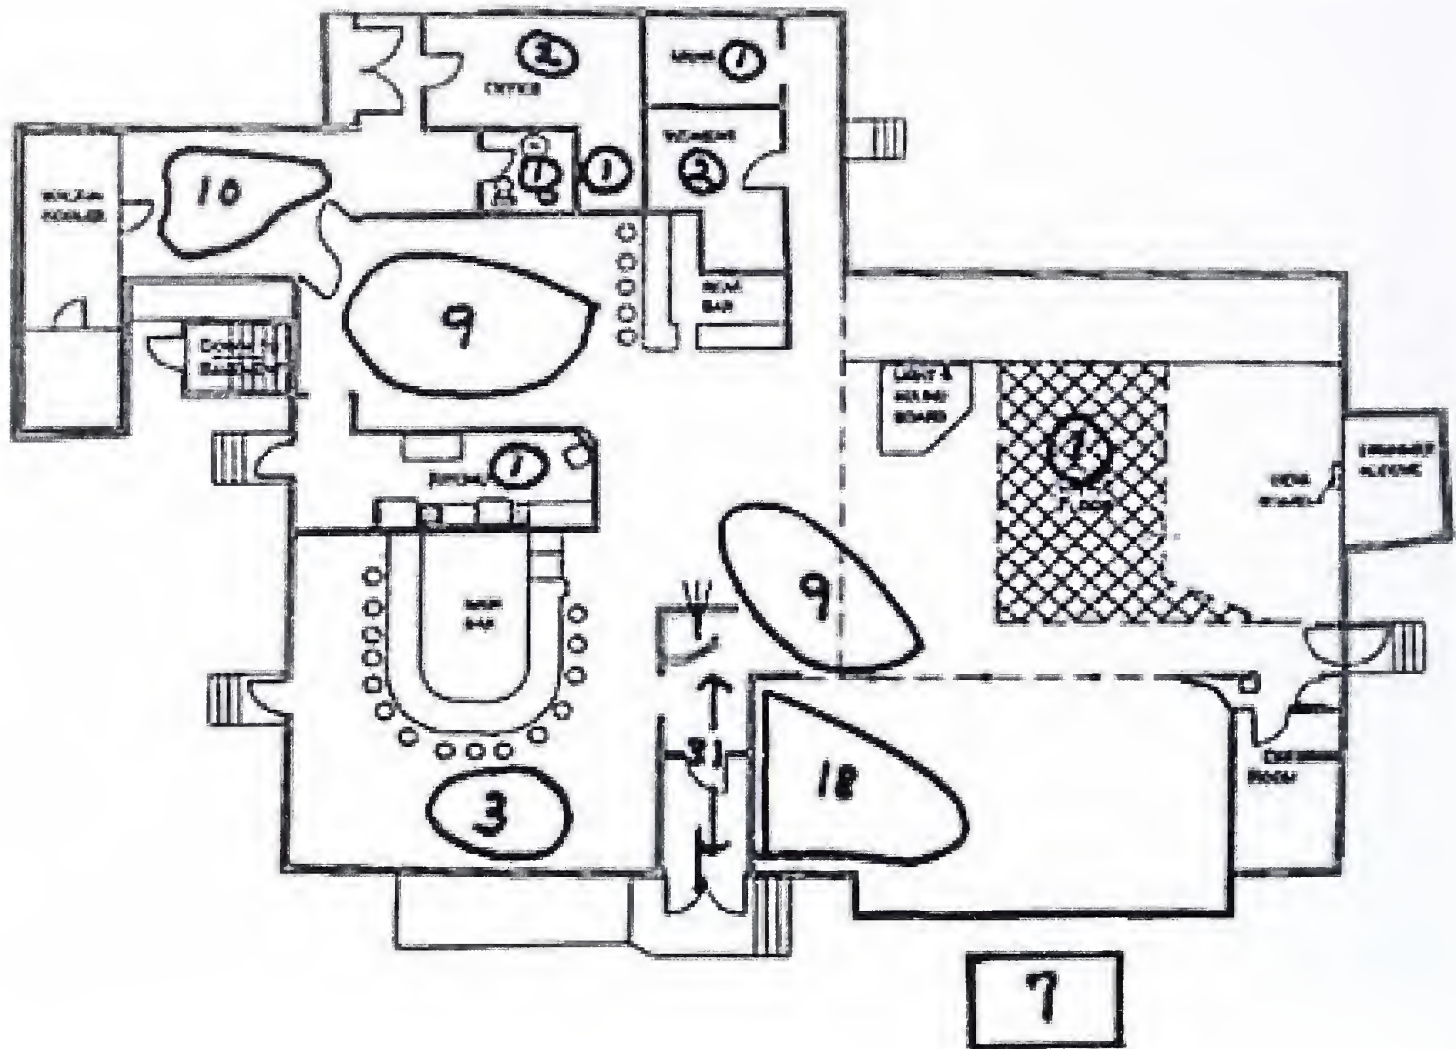
Figure 6-14. Location of Recovered People Who Died at Scene [36]

The Rhode Island Attorney General's office released a diagram of the approximate location where the rescuers recovered the 96 people who died at the scene of the fire [36] (See Figure 6-14.); 58 of these were located in the main entryway, at the entrance to the main entryway, or trapped in the sunroom. Taken together with the 91 who escaped through the front door, this translates to 56 % of the occupants apparently selecting the main entrance as a route to safety. Including the people who chose the windows only after the main exit became impassible, one could argue that as many as 2/3 of the occupants attempted (at least initially) to leave through the main entrance in the front of the building. Only about 40% of those who successfully evacuated escaped through the main entrance.

The small number of victims shown in Figure 6-14 who were found in the main bar room suggests that the main bar room exit door and windows provided open routes to escape for a time period about as long as it took to reach untenable conditions in that area of the building. By contrast, the high number of victims found in the sunroom relatively close to the windows suggests that the environment there became untenable quickly, eliminating the option of a secondary route through the sunroom windows once the platform door and main entrance became unusable. Both of these conclusions are consistent with the environmental conditions predicted in the FDS simulations discussed in Chapter 5.

Twenty-three victims were found in the dart room, storage area, and office, suggesting either that they were unfamiliar with the building and hoped to find a safe exit in that region, or that they became disoriented while heading for the side exit of the main bar room (or possibly the kitchen exit). It is unclear whether the seven people identified in Figure 6-14 as being recovered from the front of the building outside of the sunroom died as they escaped or were pulled from the sunroom by rescuers.

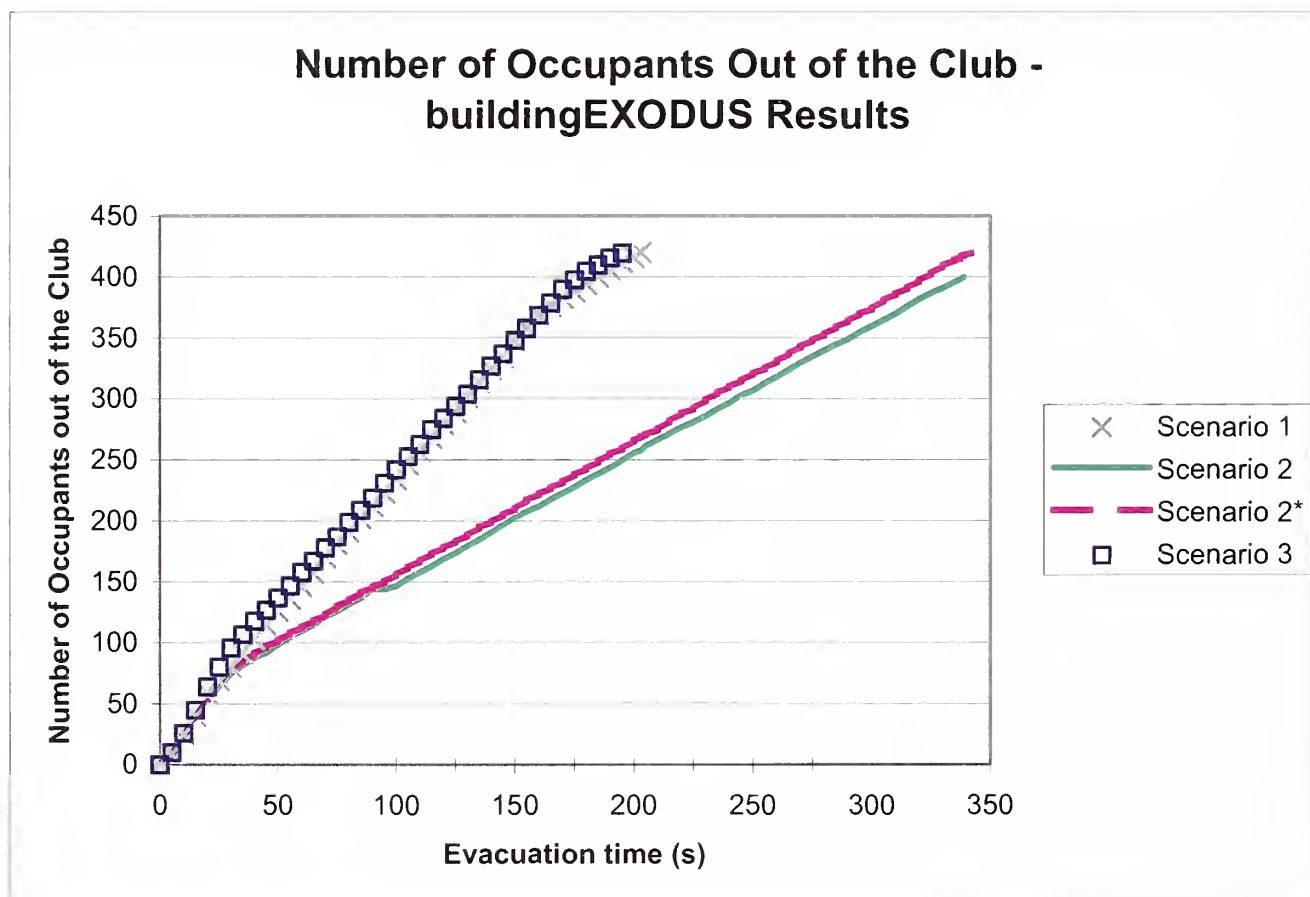
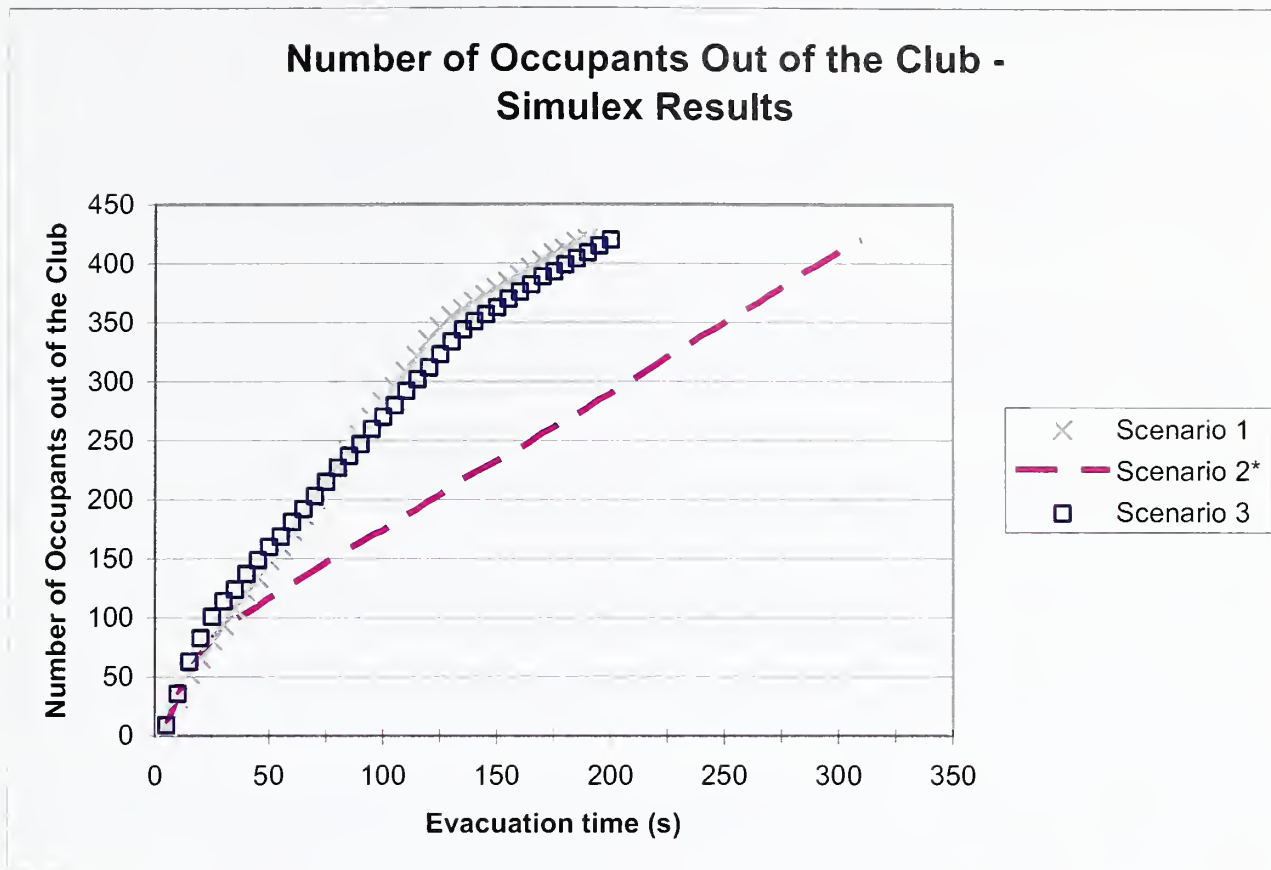
Figure 6-16. Cumulative plot of evacuation from building for different scenarios calculated from buildingEXODUS [39]. (Note that a non-zero pre-movement time would shift the curves to right.)

Ninety seconds had significance on Feb. 20 because that was about the time the front entrance became blocked and, according to the fire dynamics simulations, was a point where the conditions were becoming untenable throughout the building. The last column in Table 6-2 lists the population remaining for both the buildingEXODUS and Simulex simulations. Note that buildingEXODUS, when compared to Simulex, consistently provided a more conservative (i.e., a slower) rate of egress, which is consistent with the conservative flow rates chosen for the exit doors in buildingEXODUS.

Somewhere between 166 and 208 people were calculated to remain in the building 90 seconds after the fire began for the scenario in which the building met current national model code requirements. This number jumped to 271 for scenario 2, with the platform door blocked (recall that the front door remained open during the first 90 seconds). Doubling the entrance door width in scenario 3 brought the number of people remaining in the building 90 seconds into the fire back down to the range calculated for scenario 1. Finally, since the crowd-crush had not occurred prior to 90 seconds, the calculation for the 2* scenario is essentially the same as for scenario 2.

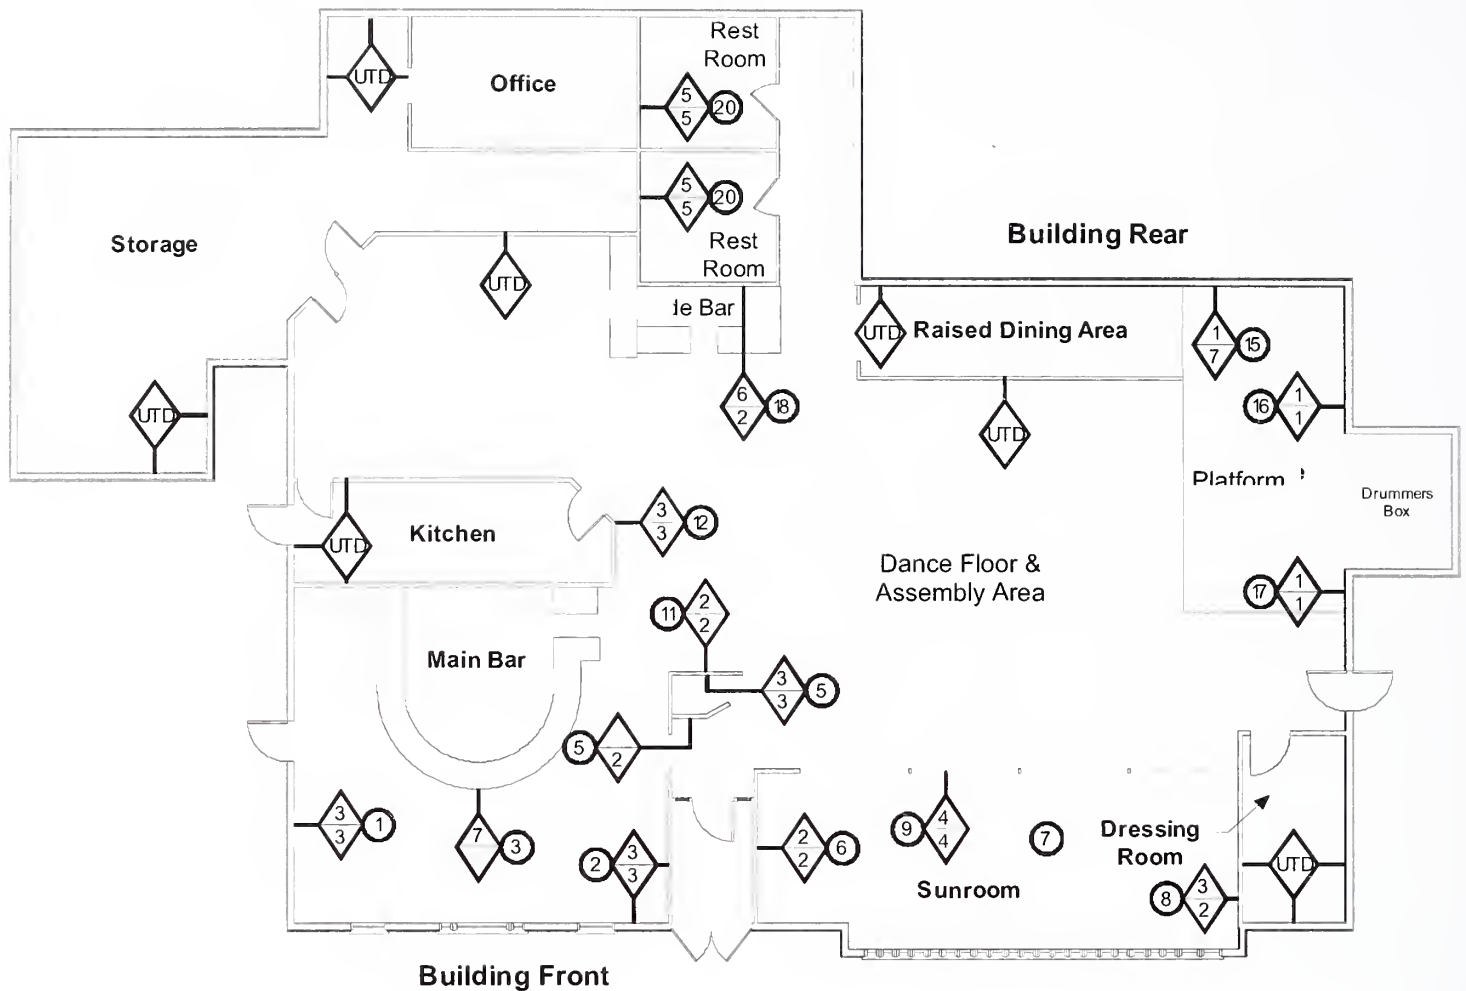
Figure 7-1. Station Night Club Ceiling Interior Finish

Comment: As would be expected, the interior finish materials of the building varied greatly. The interior finish material was mapped and is shown in Figures 7-1 and 7-2. The interior wall finishes included wood paneling, bead board, painted gypsum, wafer board, and ceramic tile. Interior finishes were identified from photographic and video records. The finishes identified were estimates based on a video and photographs taken in the building. The finishes referred to as painted gypsum may be either gypsum wall board or plaster. Neither samples of products nor model and manufacture information were available. Accordingly, conclusions regarding flame spread ratings are based upon broad product categories. The ceramic tile and gypsum do not pose potential interior finish flame spread issues.

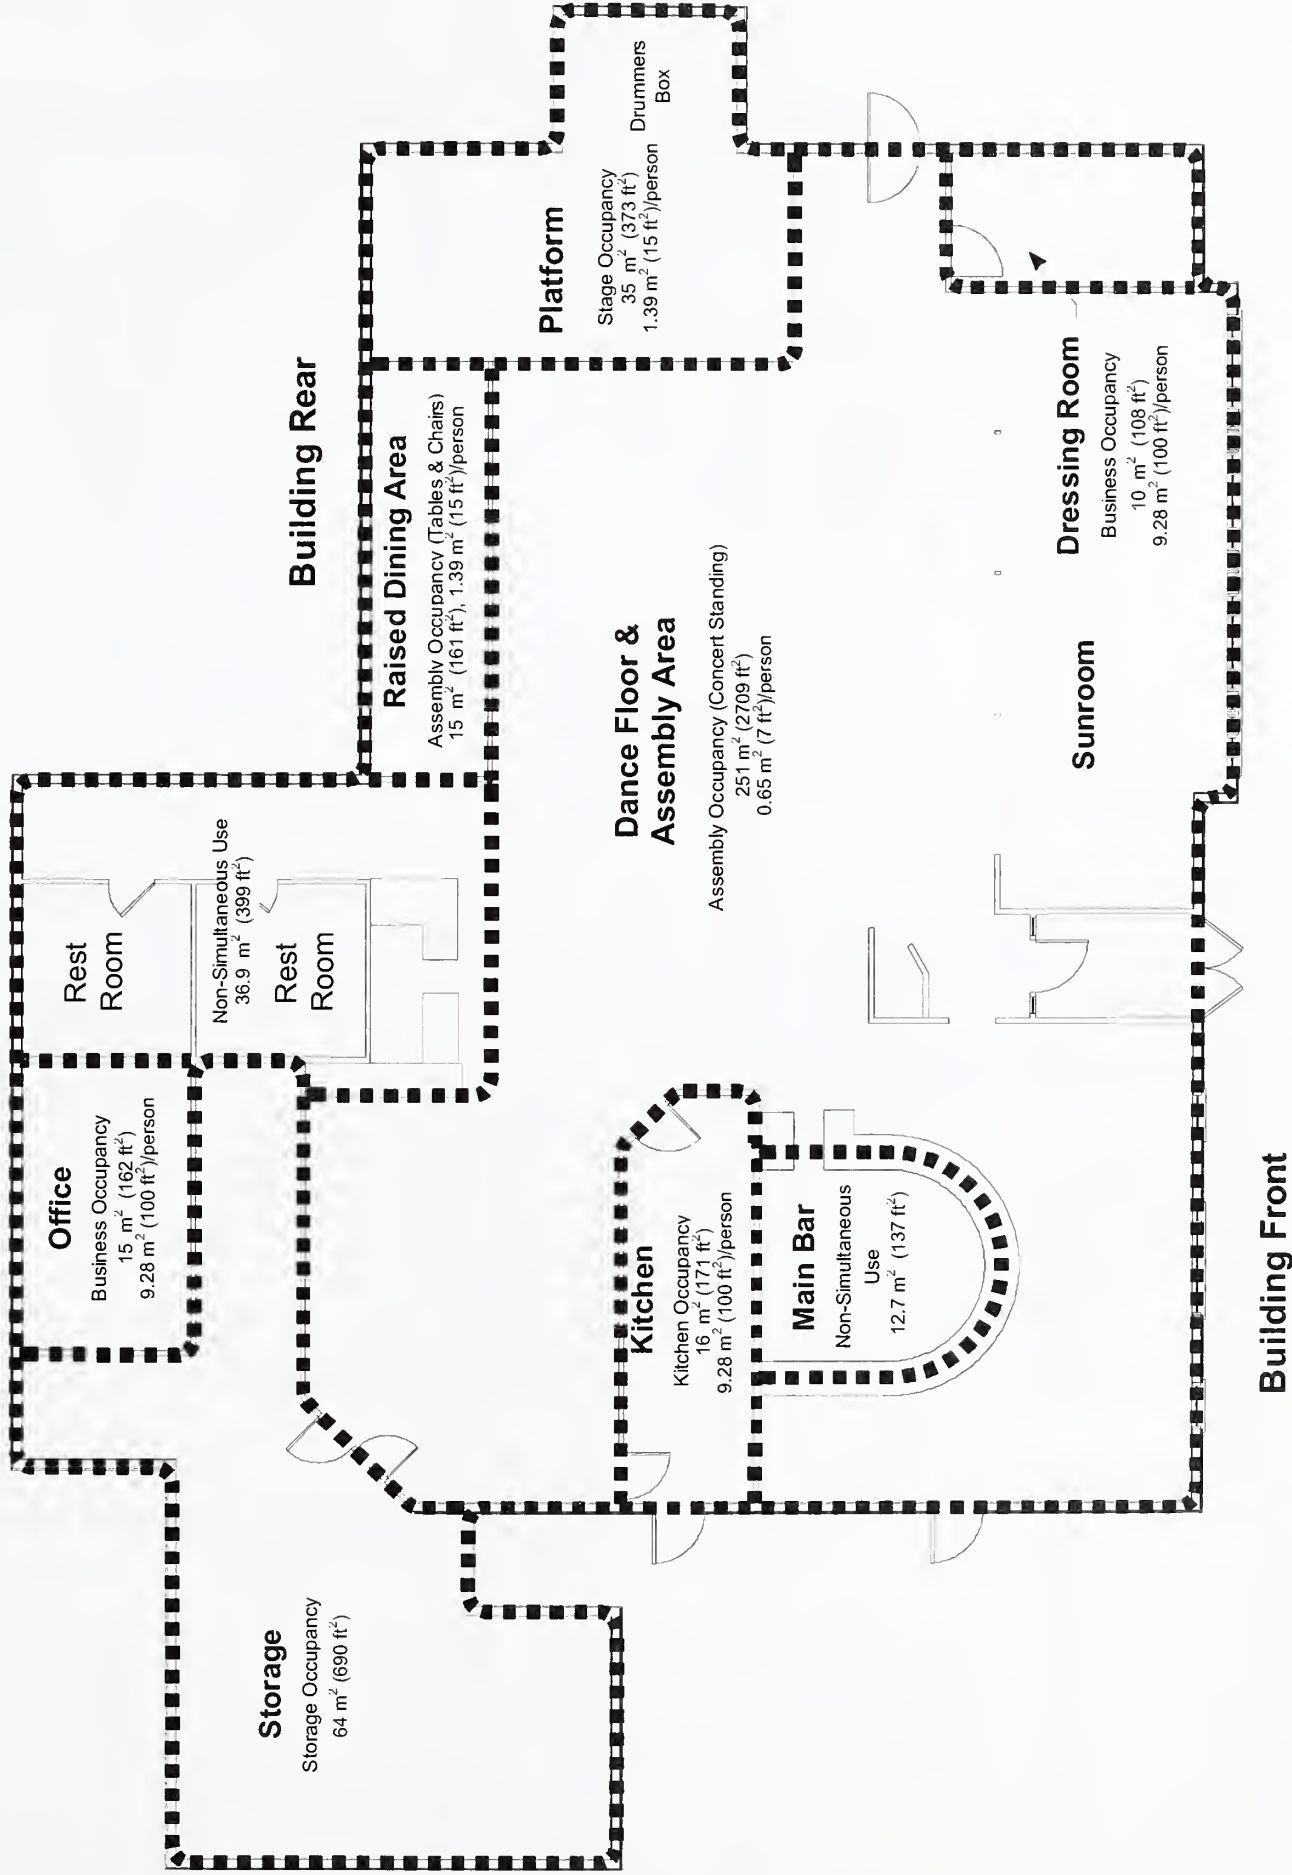
Figure 7-3. Station Nightclub (NFPA 5000) Use Area Designations

Comment: Refer to Figure 7-3 and Figure 7-4 for the use of spaces within the Station as defined by the model codes. Based upon those uses, the maximum load for each space is computed in Table 7-4. The total maximum occupancy of a building similar to The Station, according to IBC,
